Application Test

Colibrì (13.56 MHz)

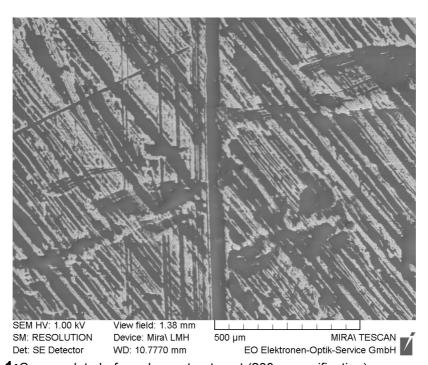
Fig. 1: Copper plate before plasma treatment (200x magnification)

The following SEM images were obtained before and after Plasma treatment with the Colibrì. The images are representative for all areas on the surface of the copper plate.

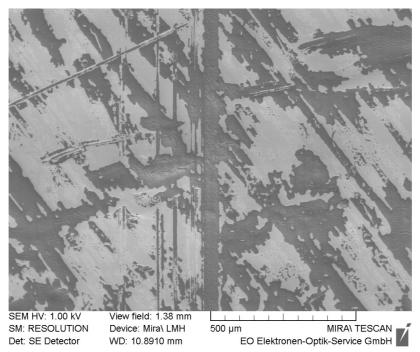
Fig. 2:Copper plate after 120s plasma treatment (200x magnification)

Although the test was performed at relatively moderate plasma conditions, the images reflect the effectiveness of this cleaning procedure. Due to the higher plasma efficiency at 13.56 MHz the cleaning effect surpasses the results seen with the 50 kHz plasma cleaner (at that time working at 150 W).

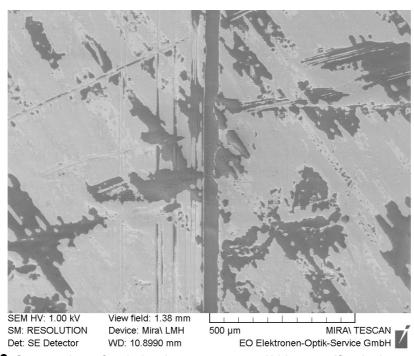
Fig. 3: Copper plate after 240s plasma treatment (200x magnification)

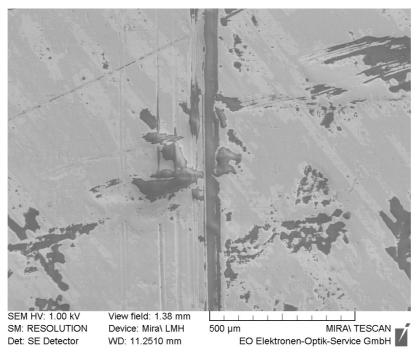
Fig. 4:Copper plate after 360s plasma treatment (200x magnification)

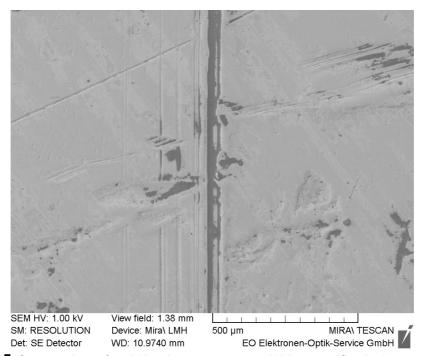
Fig. 5: Copper plate after 600s plasma treatment (200x magnification)

Due to the use of an oxygen/argon mixture the adhering oil film is readily oxidized so that even deep oil-filled grooves can be cleaned at a minimum of time.
